Metallurgical Examination of a Failed Blade Lag Shock Absorber (Part No. 114H6802) From a CH-47D Chinook Cargo Helicopter

ARL-TR-2191

March 2000

Marc S. Pepi, Scott M. Grendahl, and Victor K. Champagne
Weapons and Materials Research Directorate, ARL

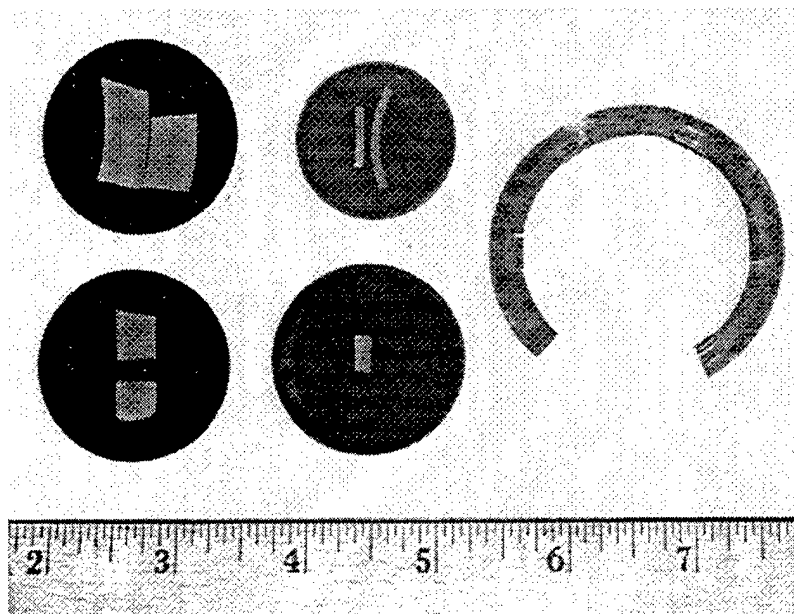
Figure 5. Mounted Samples of the Failed Blade Lag Shock Absorber and a Sectioned Collar as Received From Boeing; Reduced 28%.

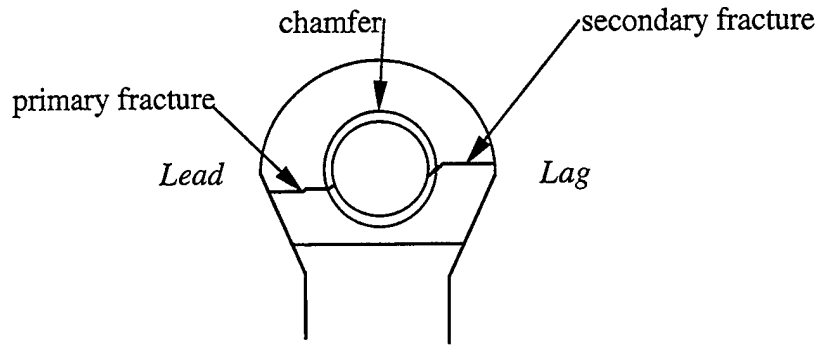
The failed part was visually examined at Boeing. The inboard lug had two radial through-fractures at the spherical bearing bore, as shown in Figure 8 [1]. The through-fractures were at the approximate positions shown in Figure 9 of the inboard lug of the blade lag shock absorber:

Figure 9. Schematic Showing Positions of Through-Fractures.

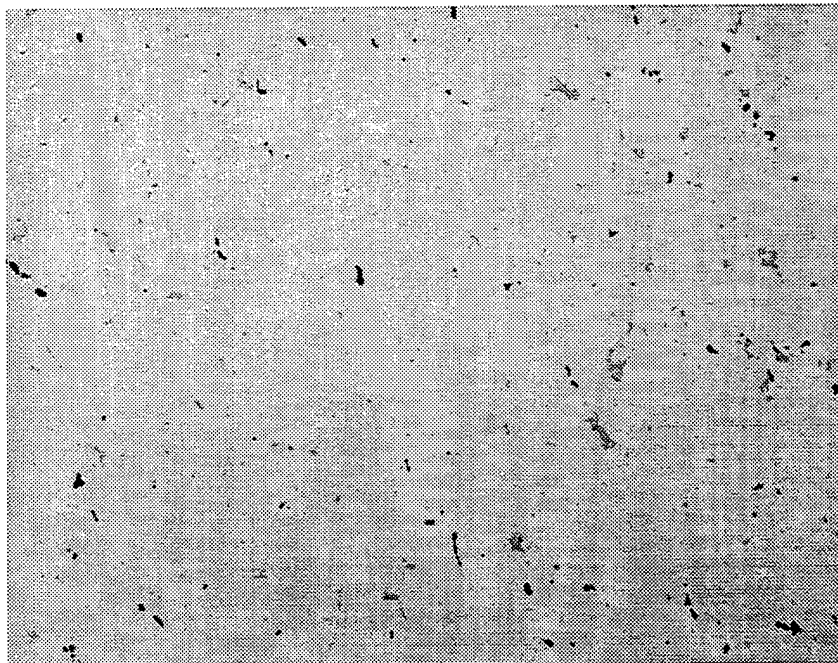
Figure 15. Micrograph of the As-Polished Microstructure of the 7075 Alloy; Magnification 200 \times .

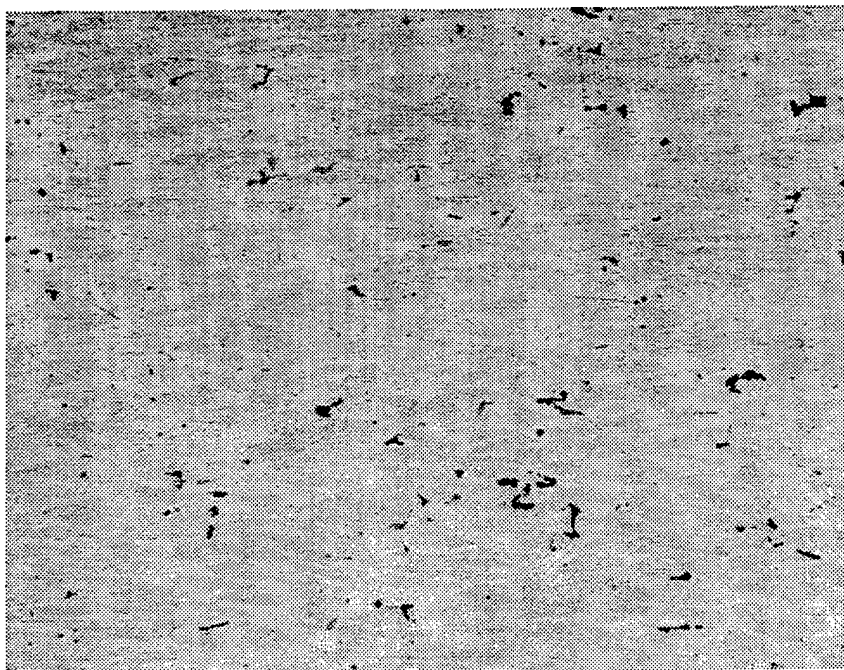
Figure 16. Micrograph of the Etched Microstructure of the 7075 Alloy; Keller's Etch, Magnification 200 \times .

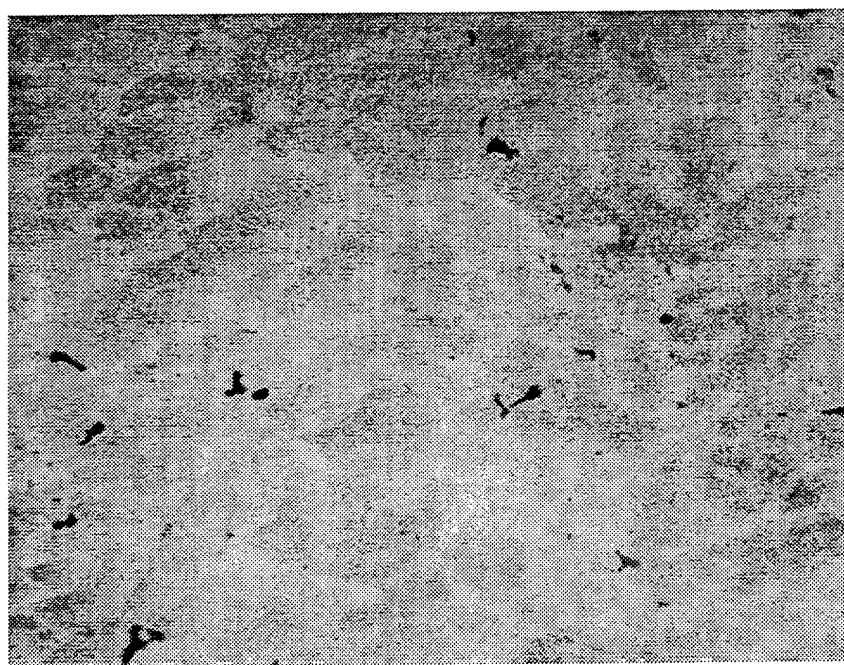
Figure 17. Micrograph of the Microstructure Shown in Figure 16, at Higher Magnification; Keller's Etch, Magnification 500 \times .

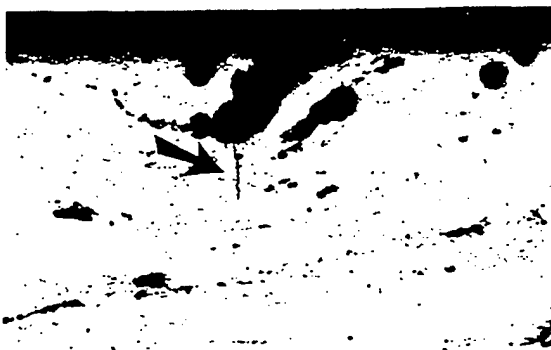
Sections were also removed approximately 10° and 90° (around the circumference of the bore) to the primary fracture. Pitting corrosion was present at both locations. A few (3), very shallow, transgranular cracking was present in the section remove one-half inch from the primary fracture but none were present in the section removed 90° from the fracture (See Figures 10a and 10b). The grain orientation 90° from the fracture was nearly longitudinal to the part length thus should have favored intergranular cracking if the hoop stress resulting from installation of the uniball bearing were the stress which caused the failure; however, no cracking was observed. It appeared very probable that cyclic tensile stress imparted at the location of the failure during operation provided the stress necessary to cause the fracture.

Figures 10a and 10b -- Views of chamfer located ~ one-half inch (left) and 90° (right) from fracture. Note small crack (see arrow) and grain orientation. Magnifications as shown.

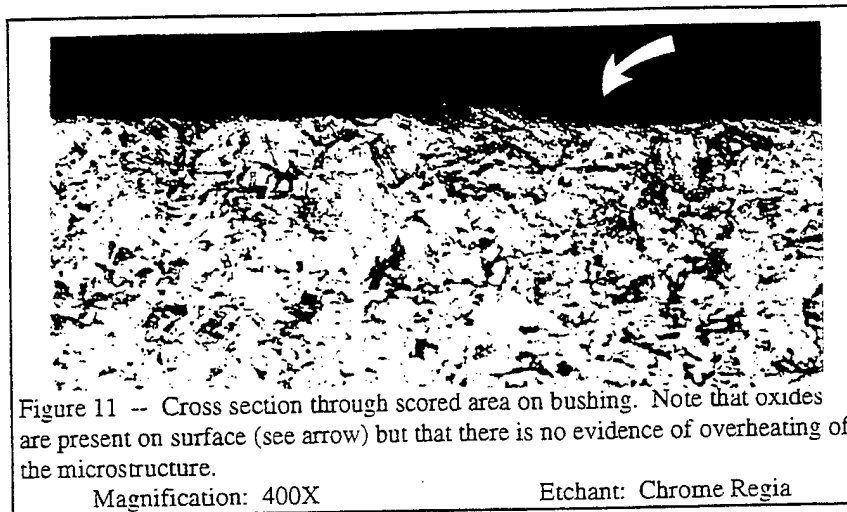
The bushing was sectioned through the scored areas. Although oxides were present in the area of the deep score marks, there was no evidence of overheating ("burning" as could result from use of a grinding wheel) in the microstructure below the scored areas. See Figure 11.

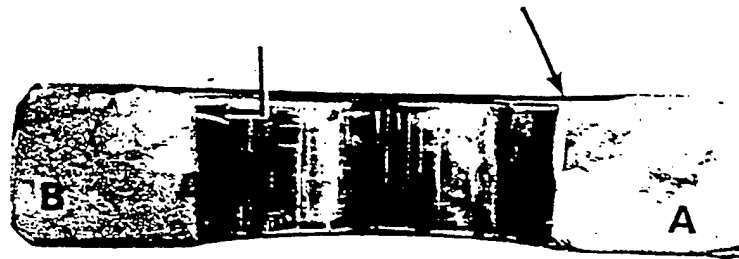
Visual examination of the as-received portions of the inboard lug disclosed two radial through-fractures at the 1.8750 inch diameter spherical bearing bore (Figure 3). The through fractures, labeled A and B, were located at approximately the 3:00 (lag side) and 8:00 (lead side) positions of the bore, respectively. For reference purposes, the 12:00 position is located at the inboard end of the shock absorber, looking down, (Figure 1). Fluorescent penetrant inspection of the segments of the inboard lug revealed no evidence of additional cracks.

Figure 3 1X
Photograph of the through fractured inboard lug displaying fatigue fracture surfaces A (primary) and B (secondary). Arrows indicate approximate origin locations.
